# DETAILED STATEMENT OF SIGNIFICANCE

*In relation to **INTERNAL AND EXTERNAL ALTERATIONS**  
at Nos 5 & 6, **TOWER STREET, CHICHESTER***

Richard Meynell Ltd with Jill Atherton *MCIfA*

May 2019

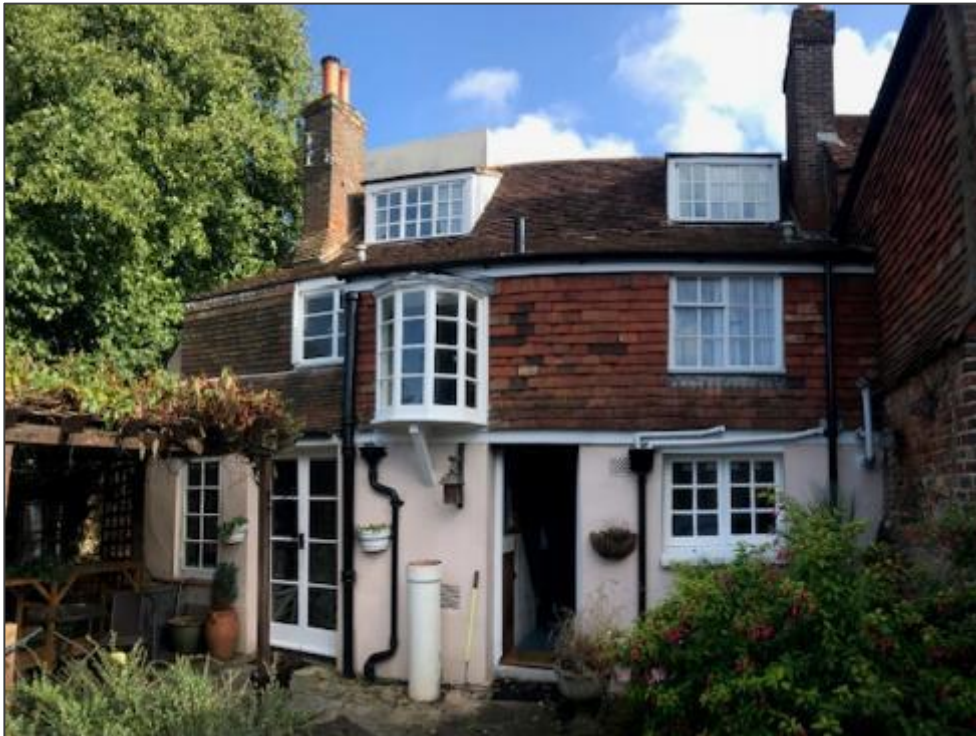
**Plate I: Rear (West) Elevation**

The rear Elevation is largely comprised of modern fabric. The modern brick walls have a modern cement render finish while the tile hanging finish is laid over modern studwork. All openings date from the C20 and do not conform to an earlier pattern or floorplan. Dormer window projections and painted timber oriel window date from the mid-late C20.

Single storey rear extension, removal of oriel window and extension of bathroom at First Floor level. Ref drawing S.1021/3J.

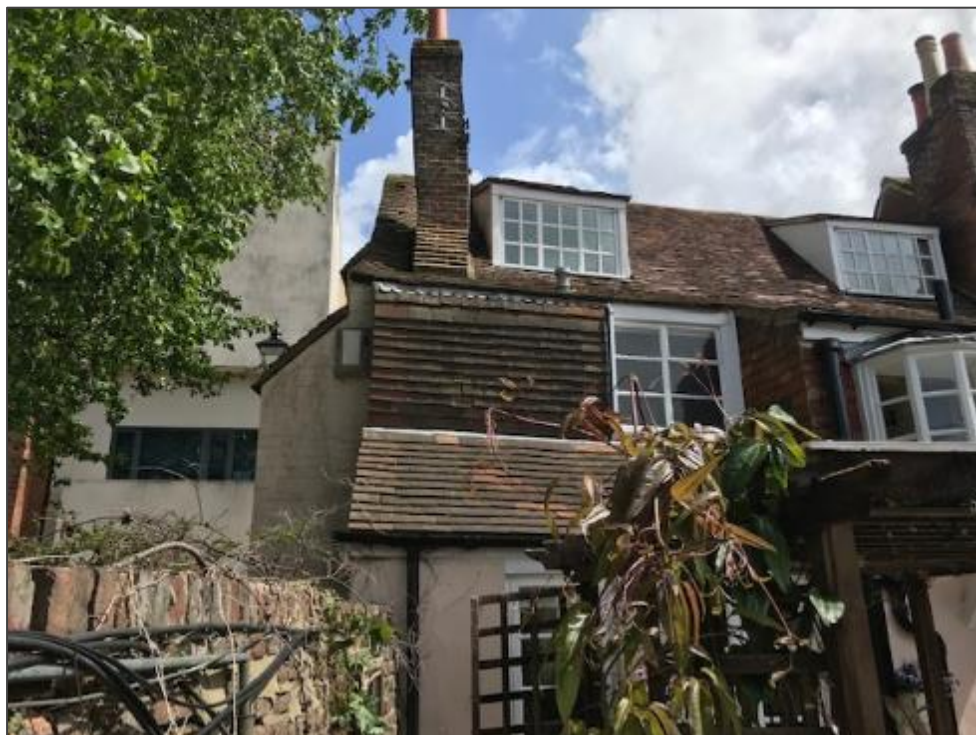
**Plate II: North end, Rear (West) Elevation. Tile hanging to First Floor.**

Site of proposed Bathroom extension. Wall and tile hanging dated to mid-late C20.

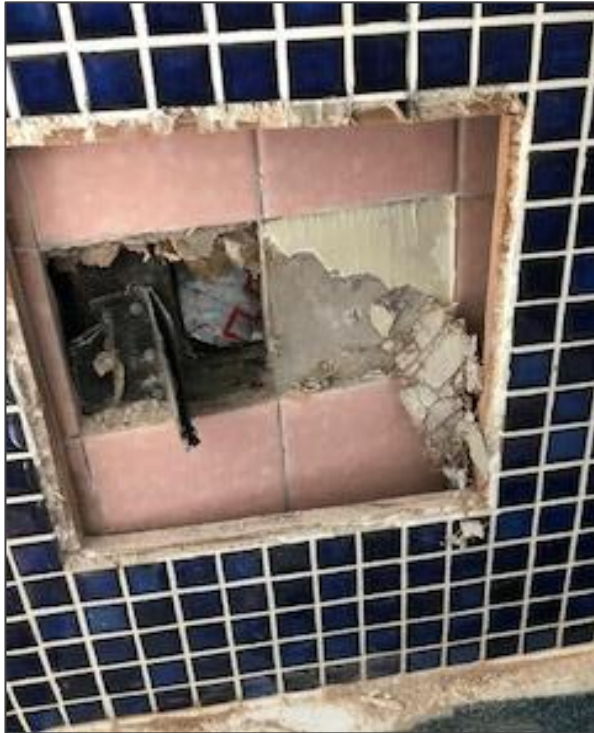
**Plates III: West external wall - To be removed to enable proposed Bathroom extension**  
200x200mm Sample area of fabric removed - all noted to be mid-late C20.

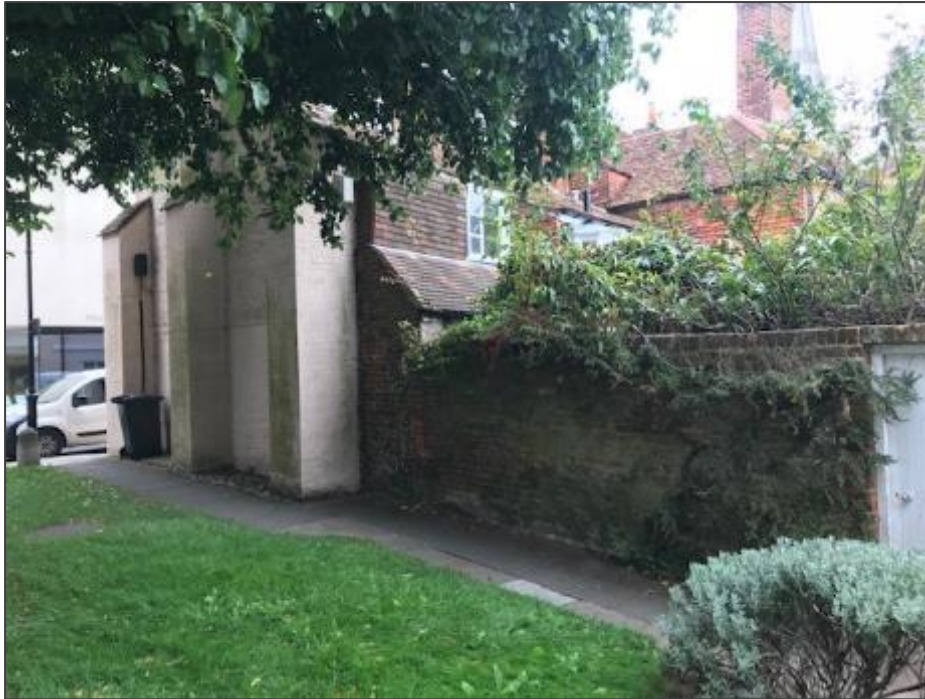
**Plate IV: Garden wall to the north side of the rear garden**

Lime mortar, flint and rubble foundation (400mm deep).  
9" handmade brickwork with no discernible bond. Brick capping course.

C18 / C19 with earlier material re-used (not in-situ)

Historic Significance – High significance. The wall is typical of many found within Chichester's city walls. The quality of construction is poor. The significance of the wall lies with the fact that it marks the historic boundary of the site (boundary believed to date to the late medieval period).

Underpinning of the wall in accordance with Structural Engineer's design to enable construction of proposed basement. Ref drawing S.1021/3J and Structural Report.

Localised repointing and conservation repairs will help to secure the future of the wall and its historic significance.

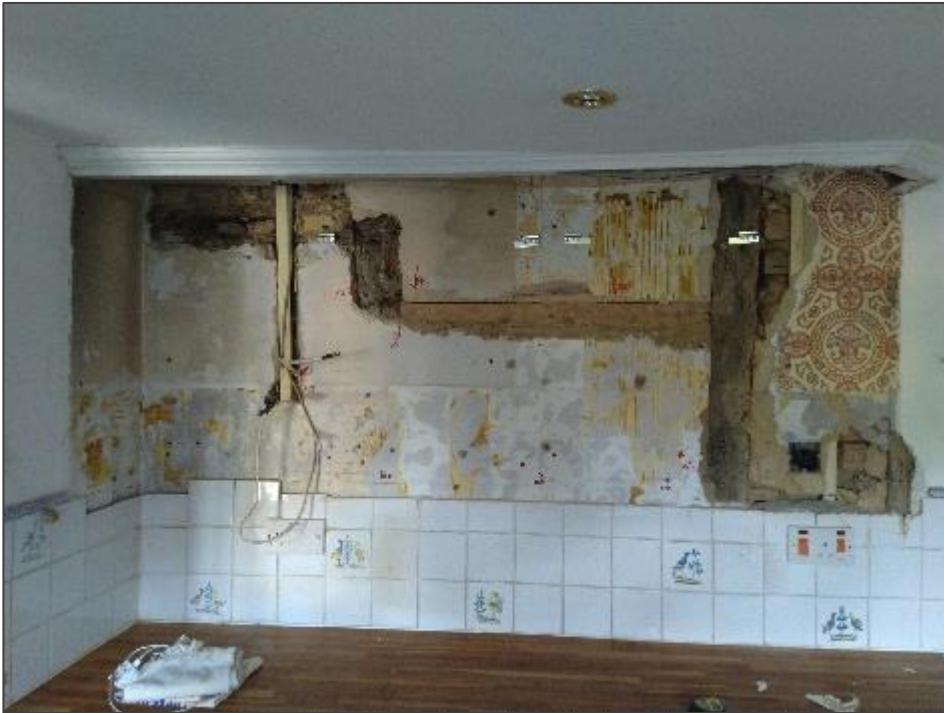
**Plate V: East wall of existing kitchen. Location of proposed door opening marked by dashed red line.**

Door opening from Proposed Kitchen to Library. Ref drawing S.1021/3J.

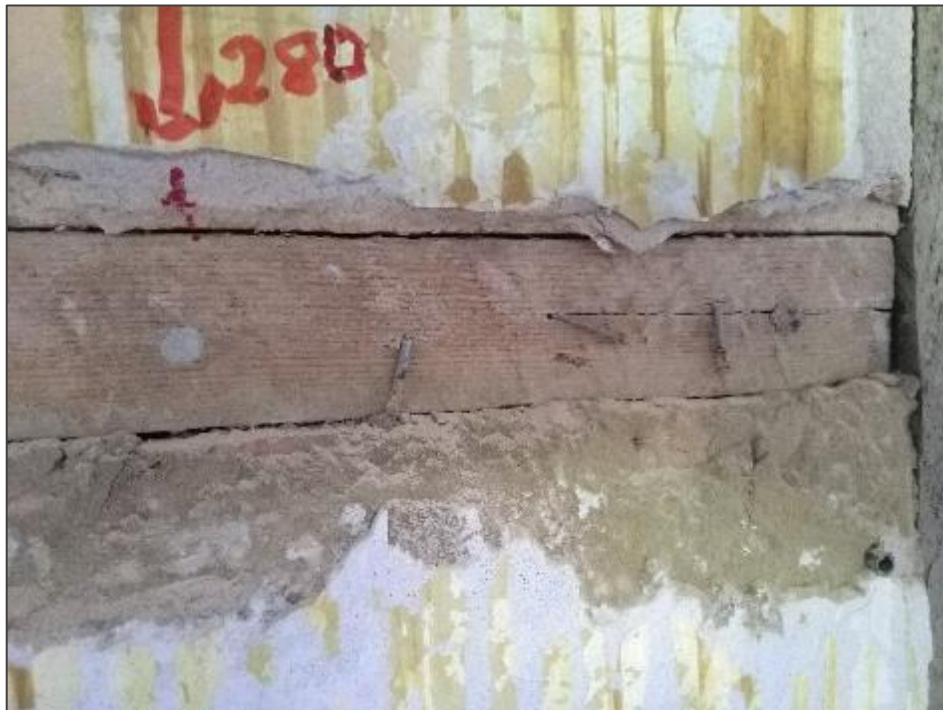
**Plate VI: Modern infill to historic door opening**  
Regularised timber rail with wire-cut nail fixings. Associated carlite plaster, brick and blockwork infill with cement mortar.

mid-C20 - The proposed opening appears to have been a doorway infilled during the renovation works undertaken during the 1950's or later.

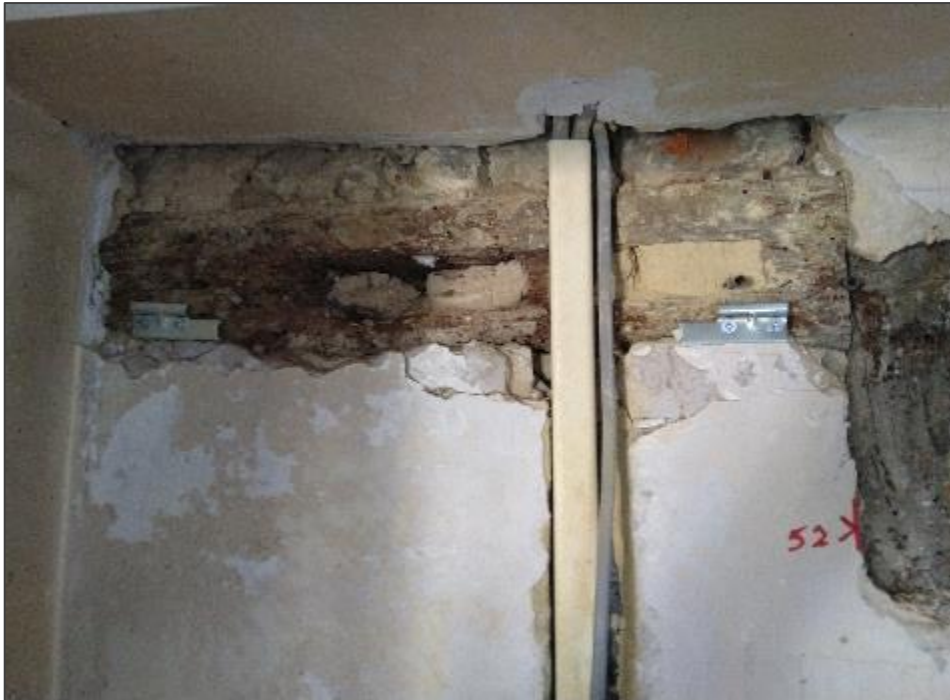
**Plate VII: North end, Re-used C16 timbers with concrete blockwork infill beneath.**  
Hollow mortice is associated with a vertical post and diagonal brace (timber not in-situ).

Archaeological recording of the wall and significant fabric has been undertaken. It is also suggested that the re-used C16 timbers are left exposed and unfinished to enable a better understanding of the building's construction and historic development.

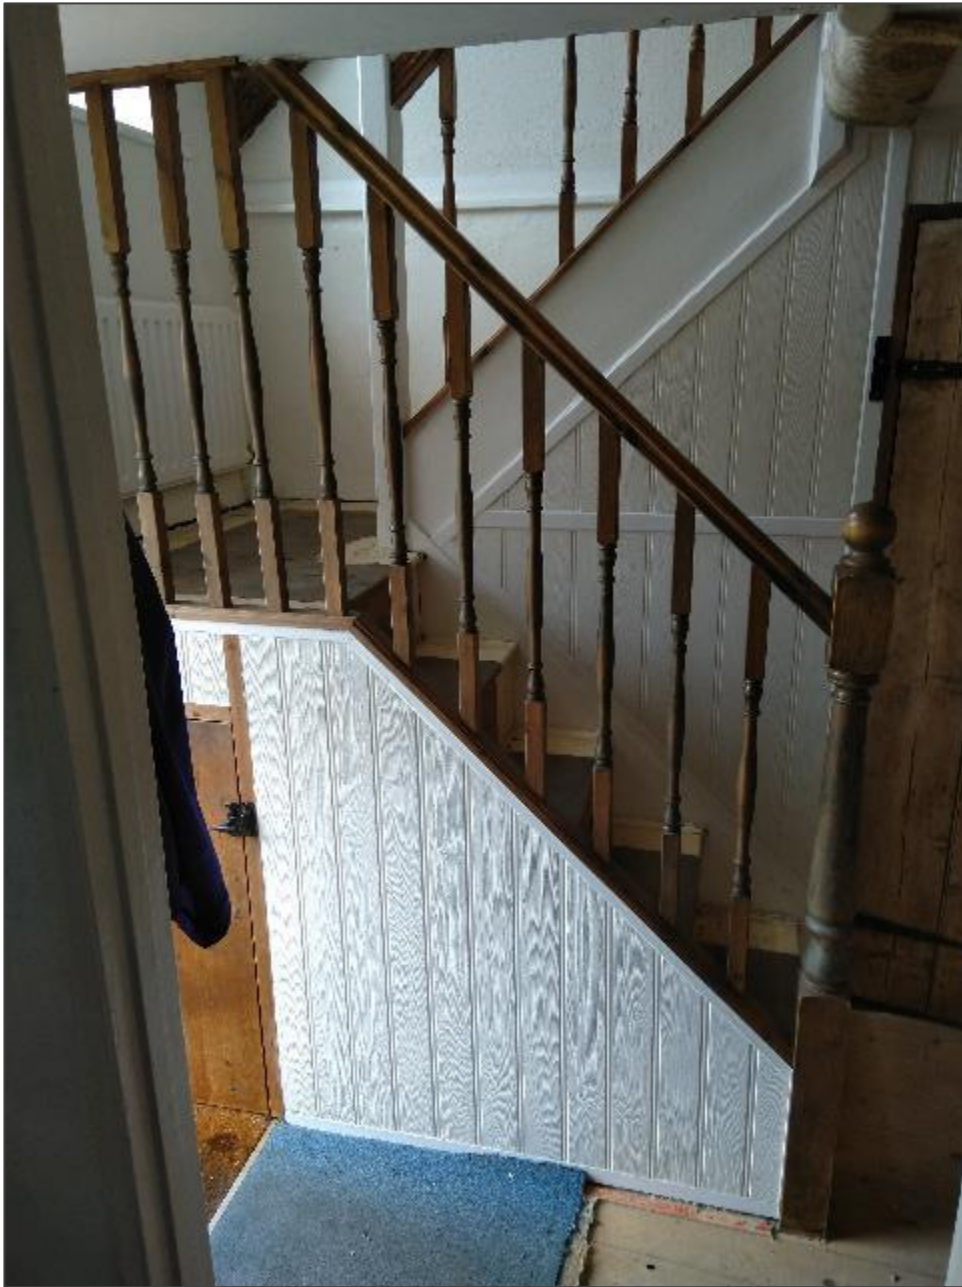
Plate VIII: Softwood timber staircase to half landing

Staircase – Painted softwood treads, Hardboard and softwood risers with modern softwood balustrade, newel posts and spindles. Wood effect fibre board. Timber studwork supporting structure.

Mid-late C20 - Both the staircase and North wall postdate the conversion from two dwellings into a single dwelling undertaken during the 1950's.

Reverse staircase in existing location and remove North wall of stairwell to form open balustrade. Replace rear door with window. Ref drawing S.1021/3J.

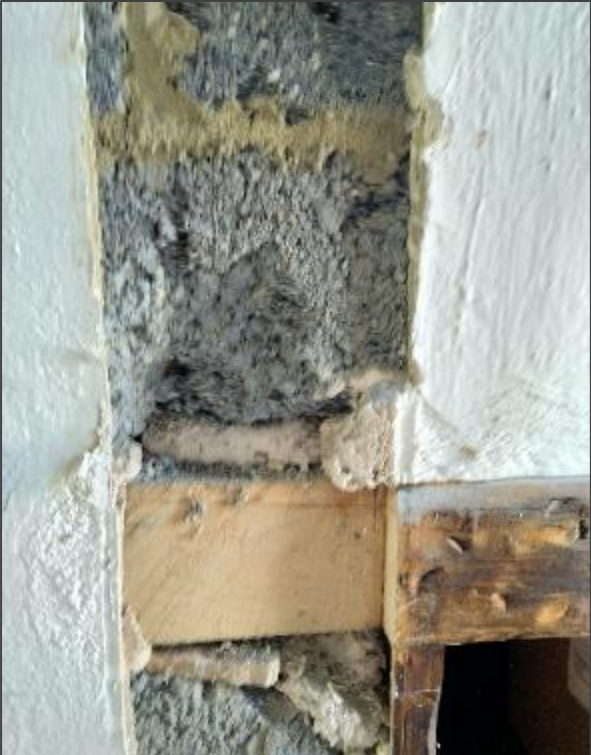
Plate X: Concrete blockwork to north wall of stairwell

North wall of stairwell – cement plaster, concrete blockwork and modern reinforced concrete and timber lintels.

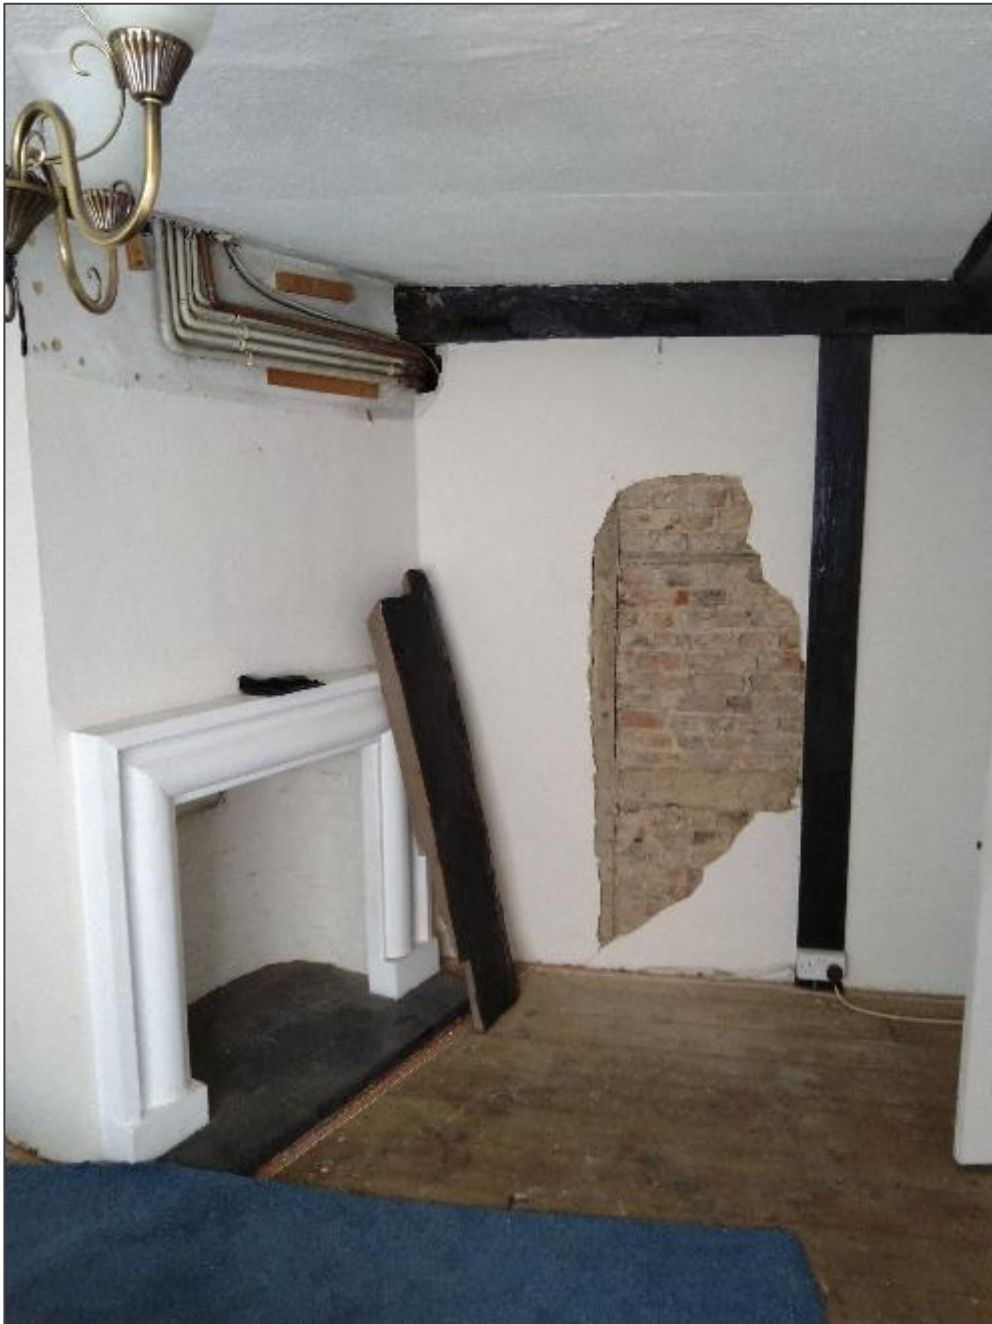
**Plate XII: West wall of South Bedroom with area of modern cement plaster removed. Re-used C16 timber over proposed door opening.**

Door opening from Bedroom to Proposed En-suite. Ref drawing S.1021/3J.

Archaeological recording of the wall and significant fabric has been undertaken. The re-used C16 timbers are to be left exposed.

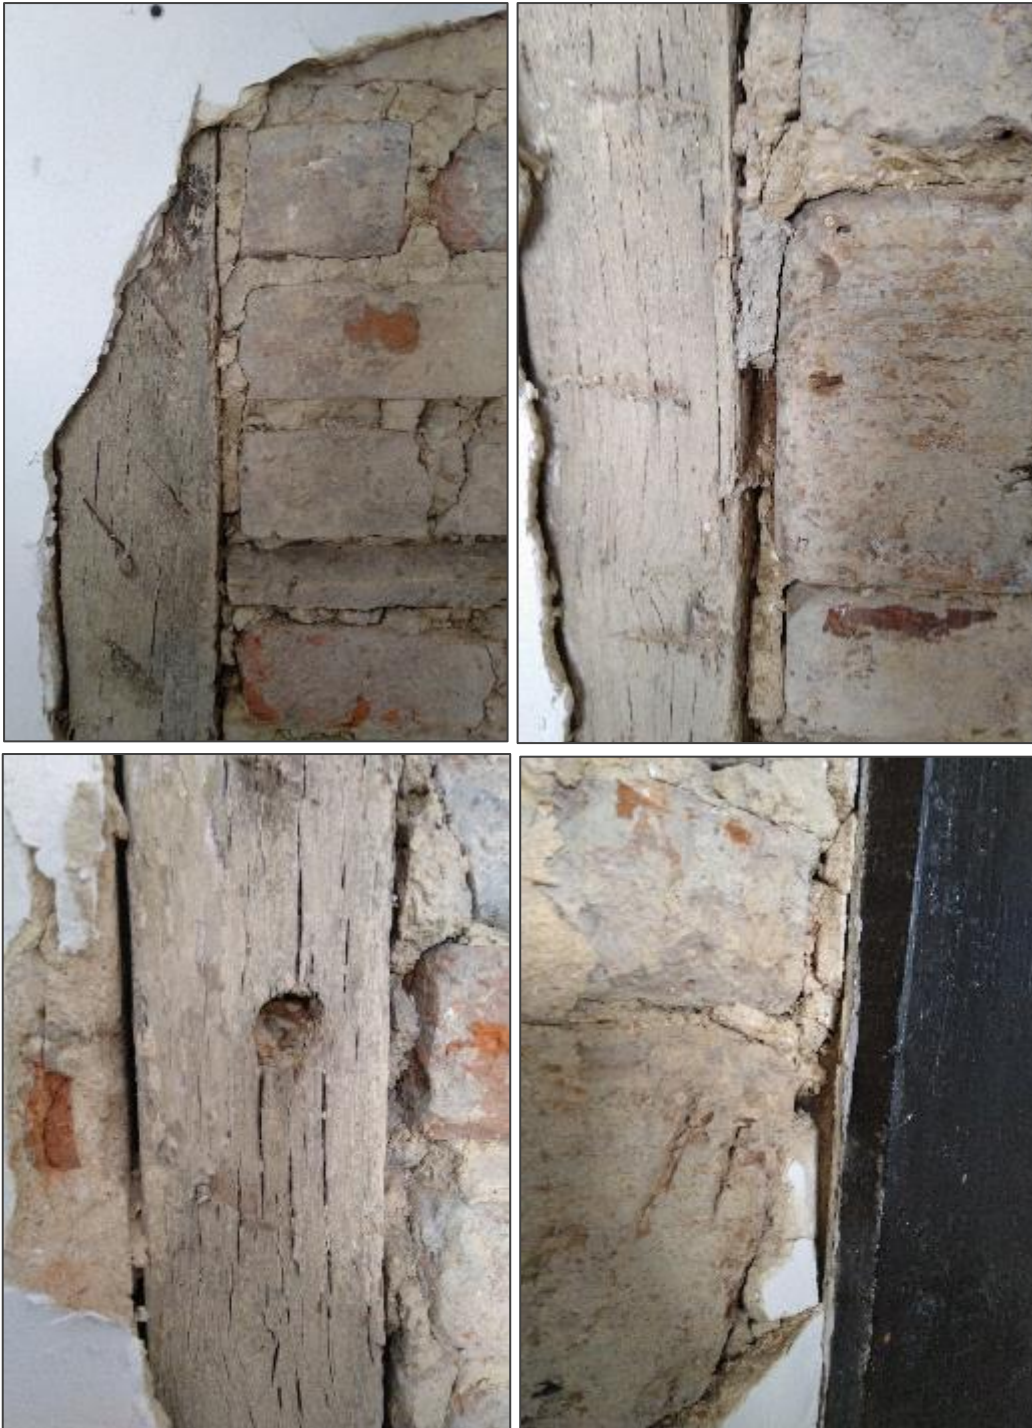
**Plate XIII: Re-used 1½" oak rail butted against 4" oak stud.**

**Plate XIV: Re-used 5" oak rail butted against 4" oak stud.**

**Plate XV: Stud concealed behind Mock-Tudor board**

**Plate XVI: Empty peg hole suggesting re-use of earlier timberwork**

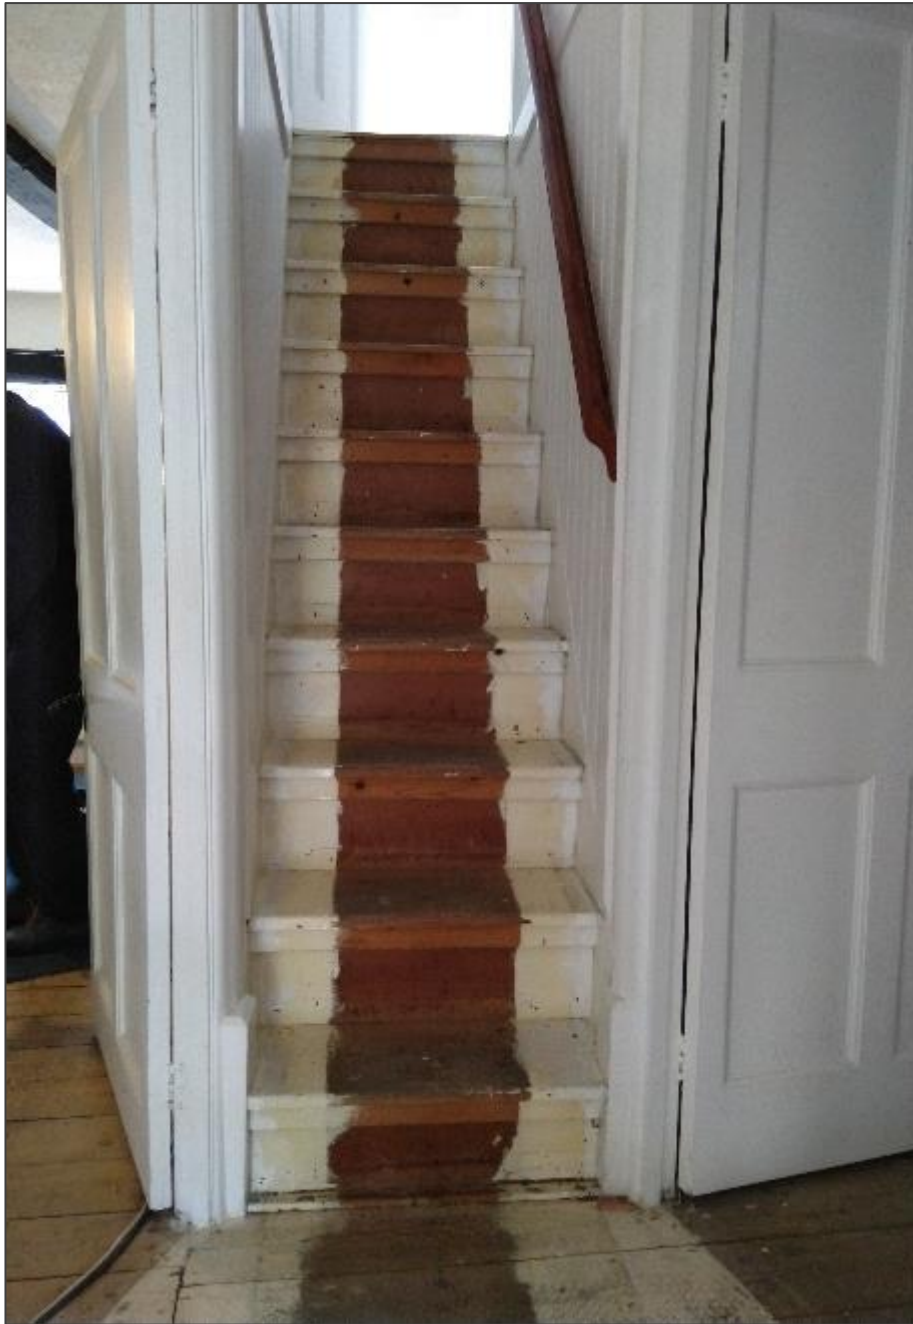
**Plate XVIII: Staircase from First to Second Floor level (view from West).**

Staircase – Softwood treads, Hardboard risers with modern handrail. Timber studwork to North and South with wood effect fibre board and plasterboard over.

Stair flight to be removed and replaced with platform lift. Studwork walls and floor locally adapted to suit. Ref Structural Engineer's drawings.

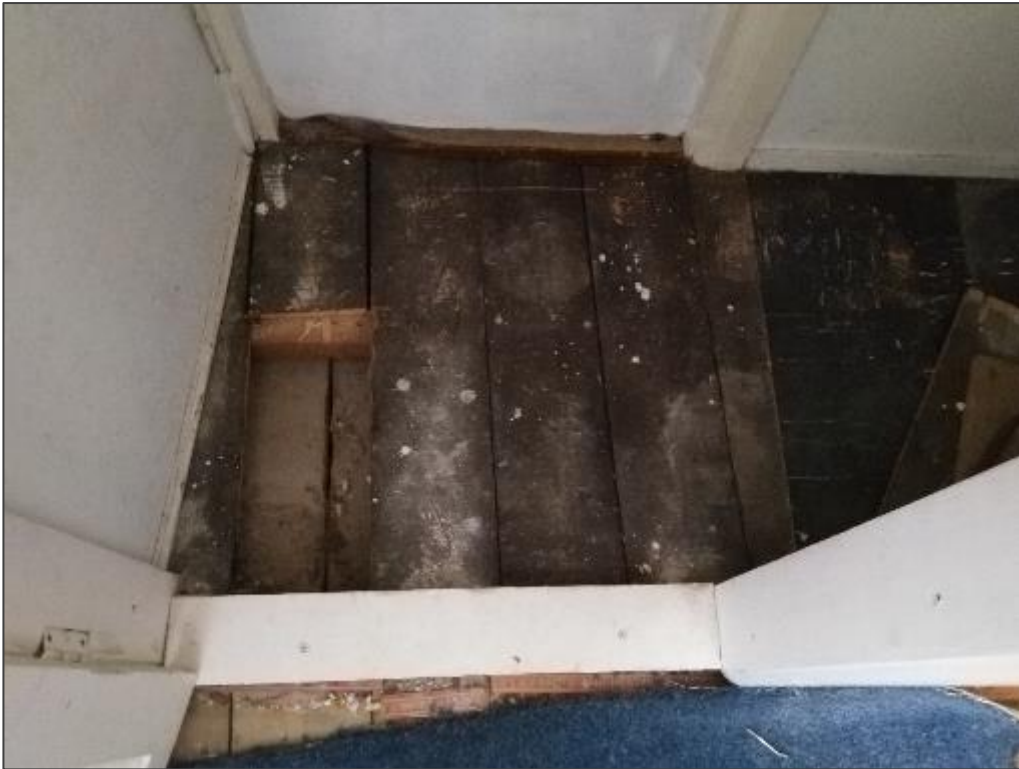
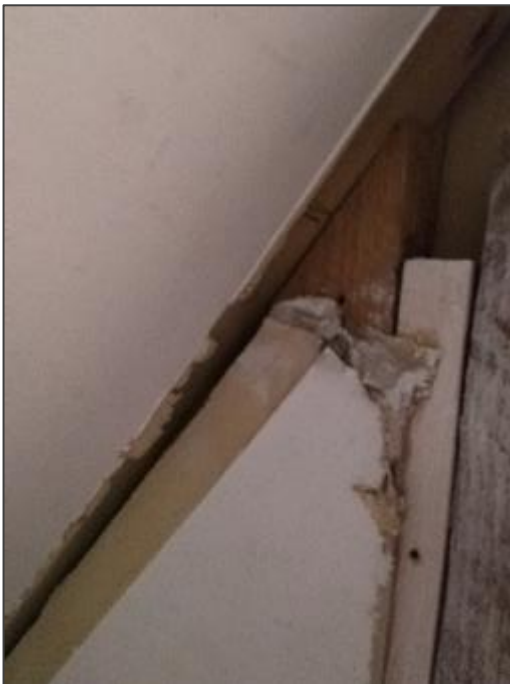
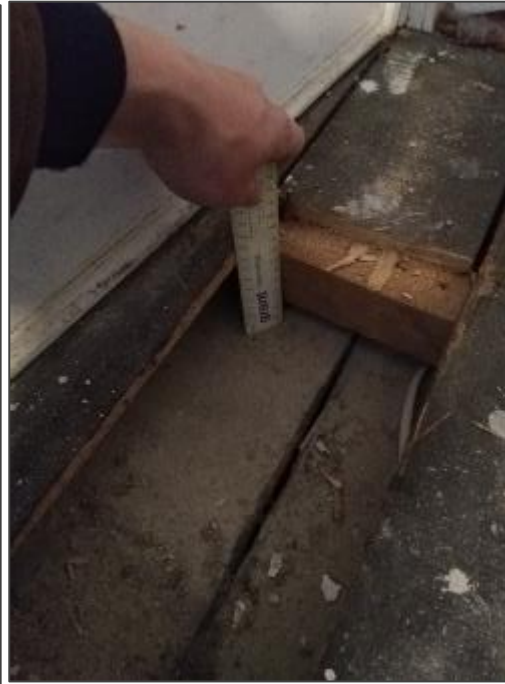
**Plate XIX: Floorboards beneath stair flight and in location of proposed platform lift**  
**Plate XX: Earlier First Floor structure overlaid with modern regularised timber and 6”**  
**floor-boards.**

**Plate XXI: Studwork to North and South of staircase formed of modern timber and**  
**plasterboard in poor condition.**

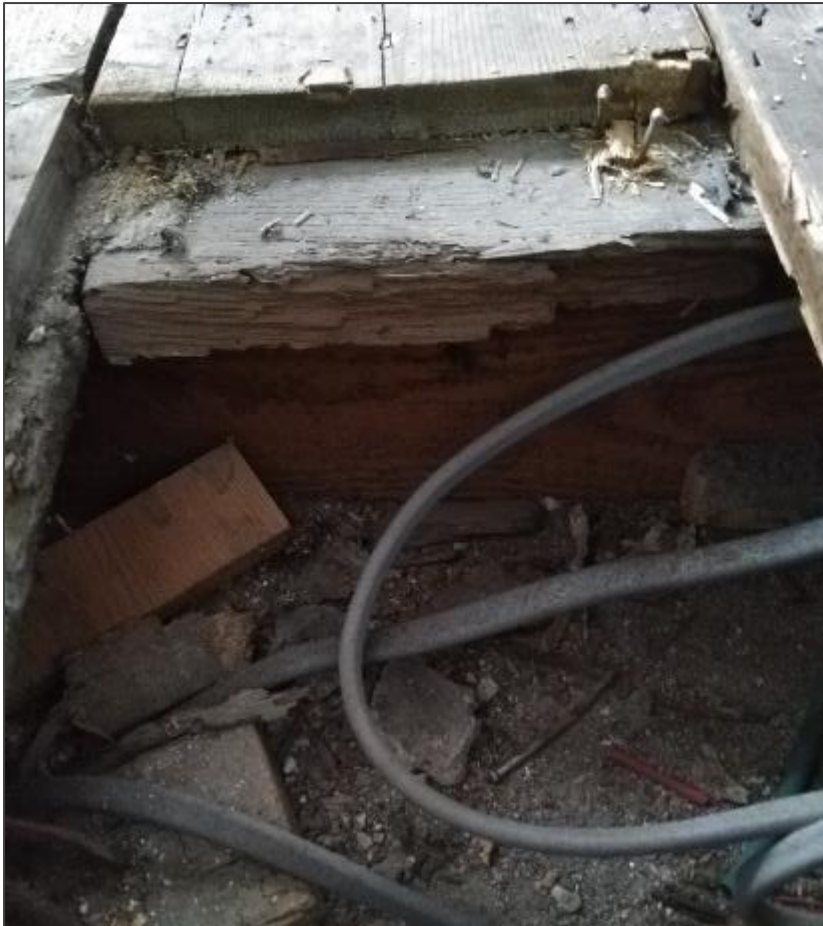
**Plate XXII: Attic Floor, re-used boards overlaid with new. Modern joists adjacent staircase.**

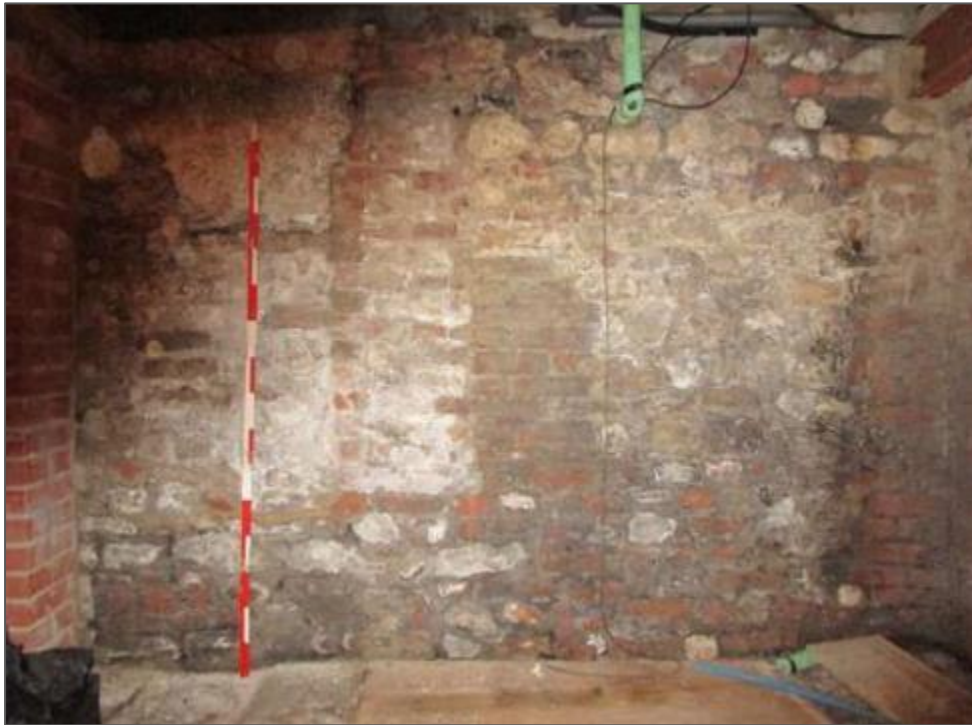
Plate XXIII: West wall of North cellar.  
Proposed door opening marked with red dashed line.

Door opening from Proposed Family room to Proposed Lobby in existing North cellar.  
Increase height of opening between existing North and South cellars. Ref drawing S.1021/3J.

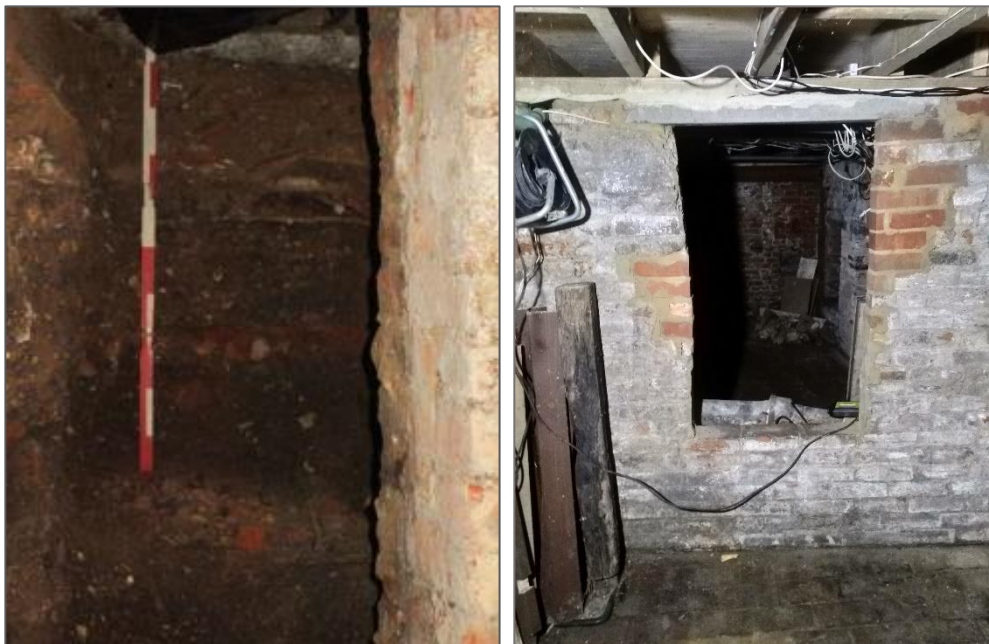
Left to right  
Plates XXIV: Existing opening from South cellar into existing void  
Plate XXV: Existing opening from North cellar into South cellar

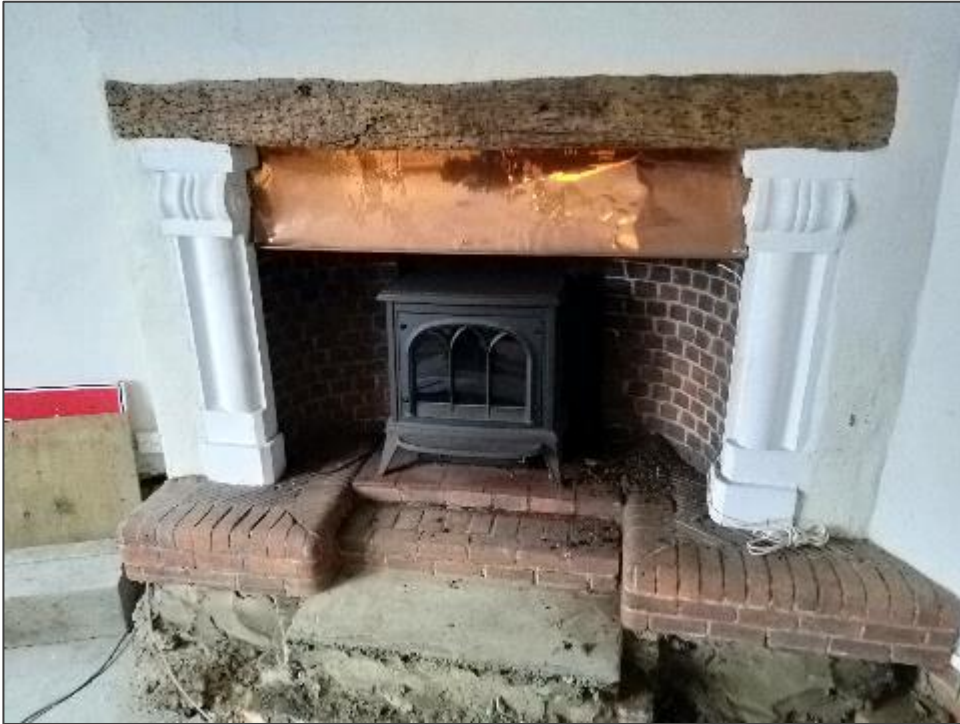
**Plate XXVI: Fireplace within existing Dining Room**

Good quality early-mid C20 brickwork to the fireplace bordered by two pre-formed concrete pilasters.

Removal of concrete pilasters and sand blasted mantle shelf. Making good of brickwork and lime plaster using matching materials. Ref drawing S.1021/3J.

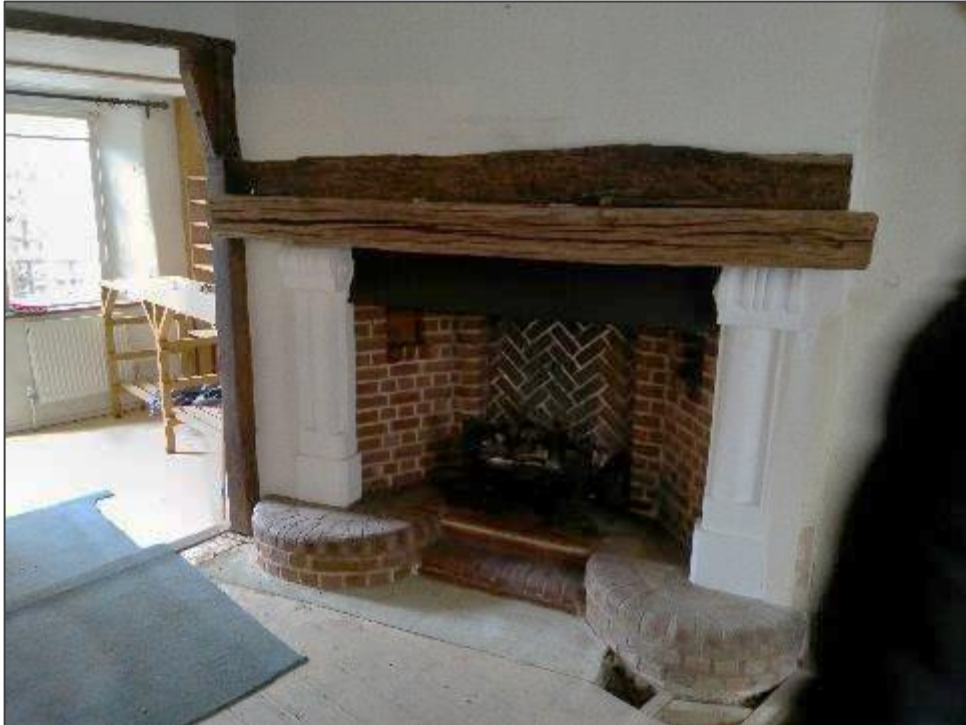
**Plate XXVII: Fireplace within existing Living Room**

A heavily sand blasted and re-used oak mantle shelf rests on two pre-formed concrete pilasters. Behind these features exist an original oak lintel and good quality early-mid C20 brickwork.
